**TIM STUBBS**  
LIMITED

# Survey level two: HomeBuyer report - Survey and Valuation

9<sup>th</sup> December 2016

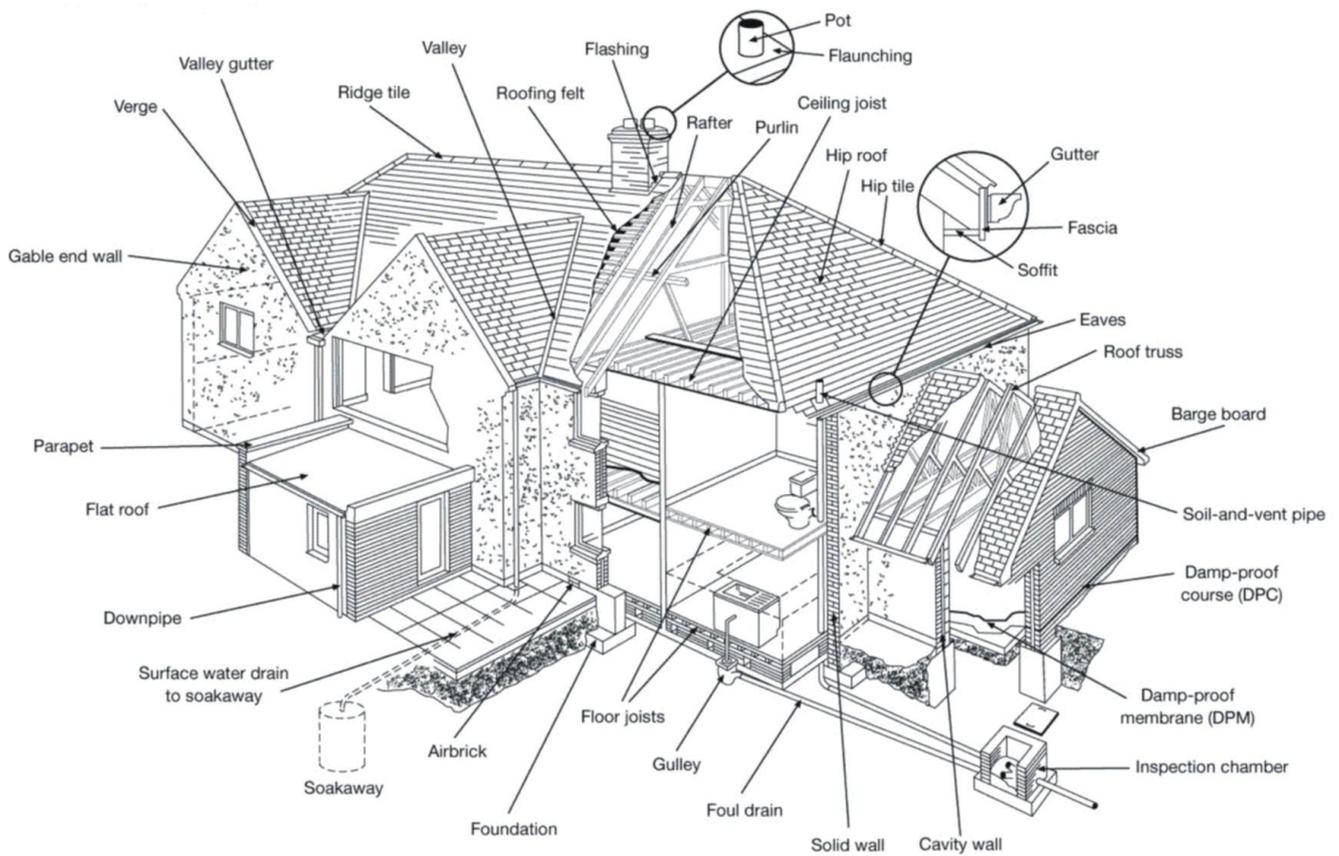
# Typical house diagram

This diagram illustrates where you may find some of the building elements referred to in the report.
