# **Survey level two: HomeBuyer report - Survey**

Property address

Mr A

6<sup>th</sup> December 2016

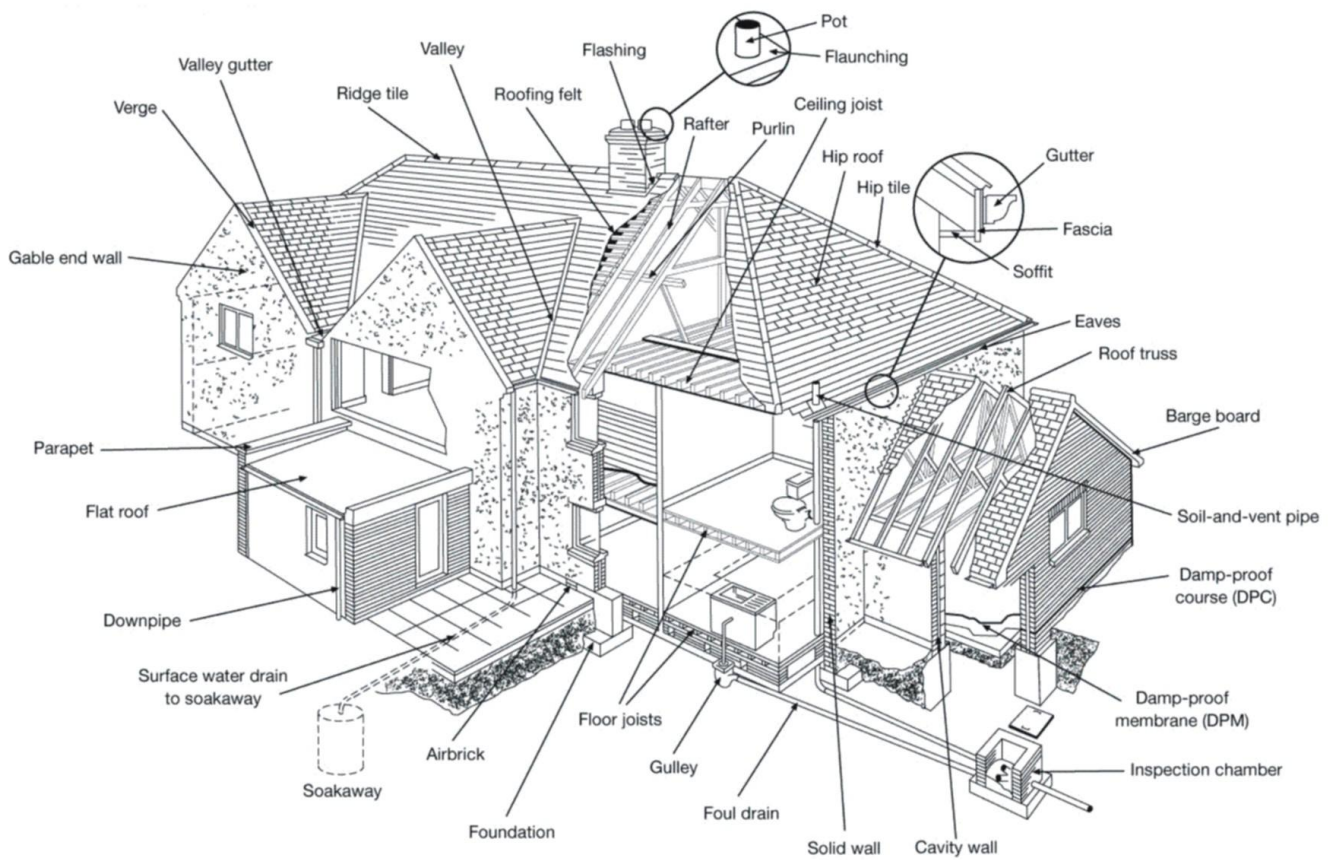
# Typical house diagram

This diagram illustrates where you may find some of the building elements referred to in the report.
